Press information – NOJ 393

Background history, technical inspection and restoration information supplied by: Joe Jarick, Austin-Healey Special Test Car and 100S historian, with contribution from Steve Pike, proprietor, Marsh Classic Restorations

1953 Austin Healey 100 Special Test Car

Chassis No. SPL 226/B

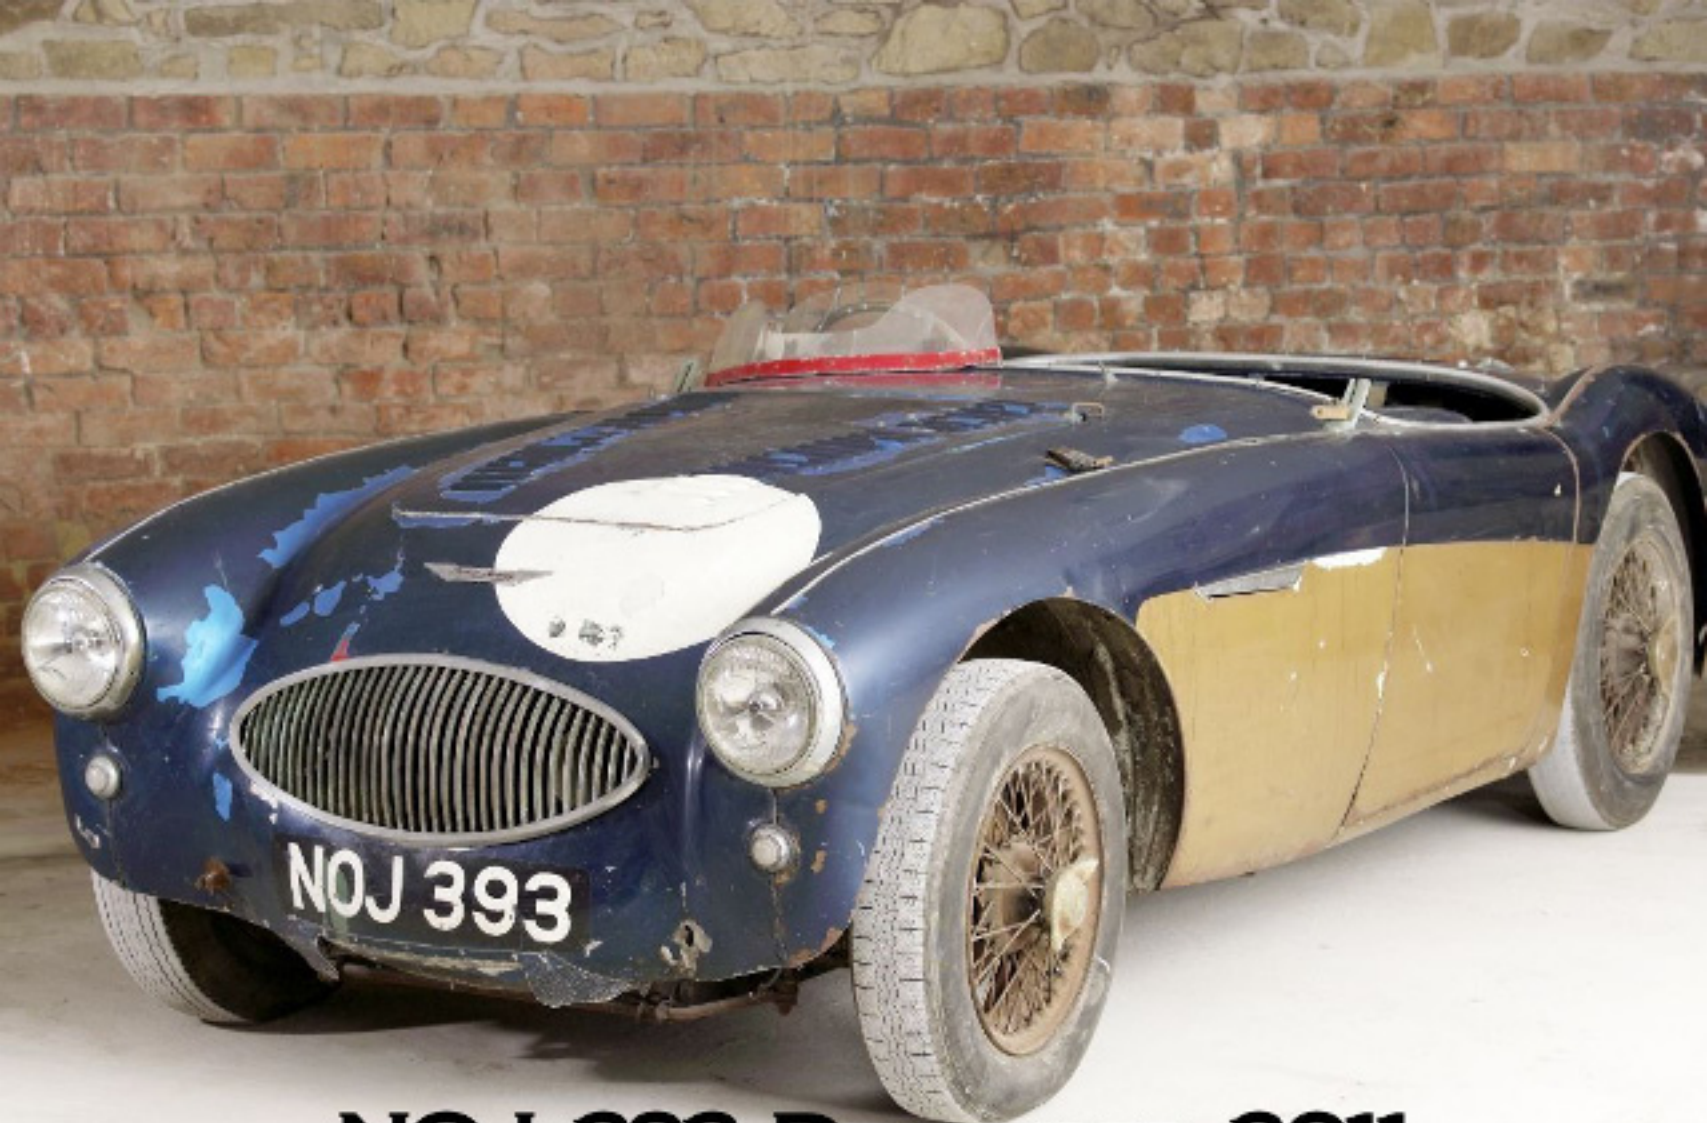
NOJ-393 DECEMBER 2011

As NOJ 393 presented it was painted deep metallic blue with a light gold flash, gold wheels and silver on the inner panels and underneath the car. The interior was dark blue with a vented 100S style seat for the driver and a 'standard' style Austin-Healey 100 seat fitted on the passenger side. Outwardly, the Healey looked complete but decidedly down at heel, this primarily being due to it being stored for decades in a range of situations.

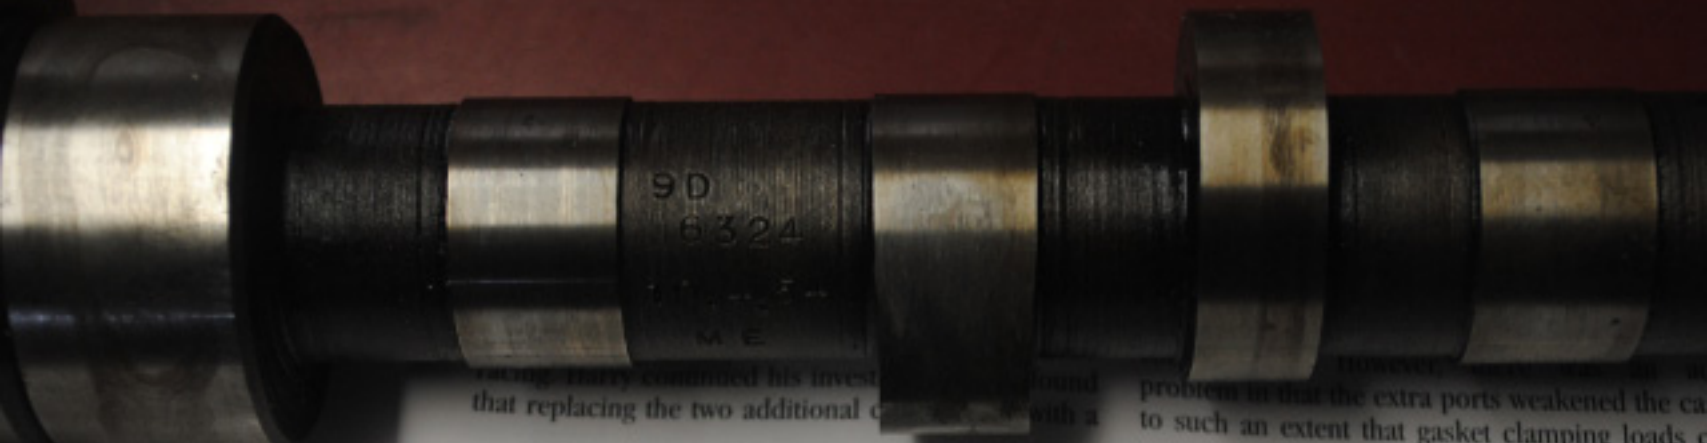
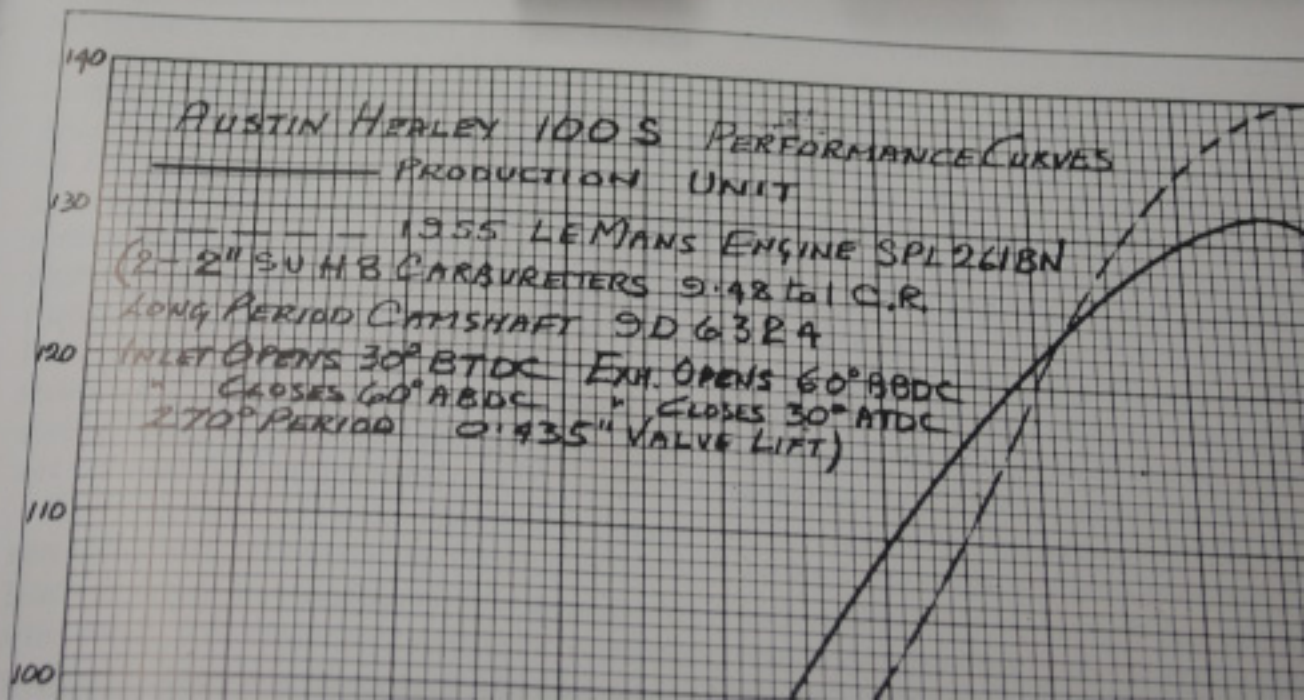
A month later the engine was completely dismantled. Though it had been seized it was found to be in surprisingly good condition. On investigation the camshaft numbers matched the dynamometer sheet for NOJ 393's engine as referenced on page 79 in Geoff Healey's book "The Healey Story" (See photo No. 9).

Figure 2: Austin-Healey 100S performance curves.
